Asbestos Survey 2173 Drew Valley Road Atlanta, Georgia

Project Number
2013.3813.02

Report Date:
June 26, 2015
Survey Date:
June 16, 2015

RE: Report of Asbestos Survey
2173 Drew Valley Road
Atlanta, Georgia
Project No. 2013.3813.02

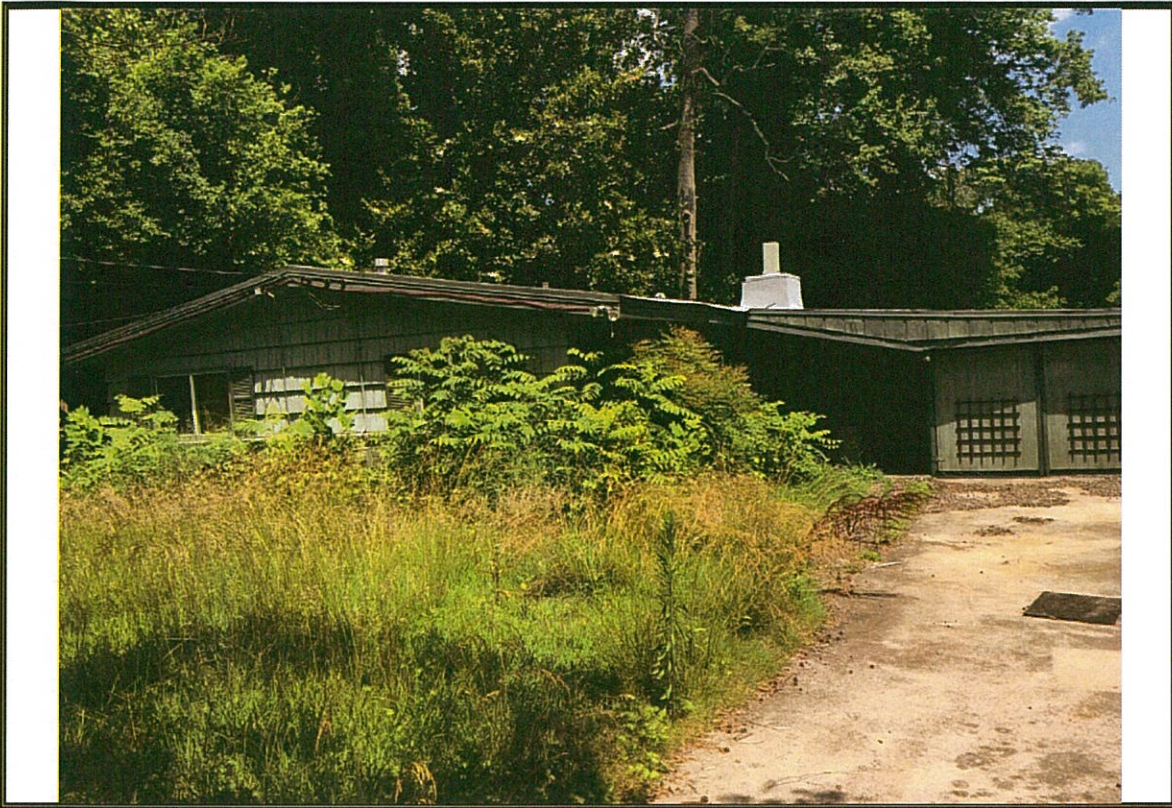
Photo # 1: The Project Site building consisted of a residential home constructed with vinyl-siding and an asphalt shingle roof.

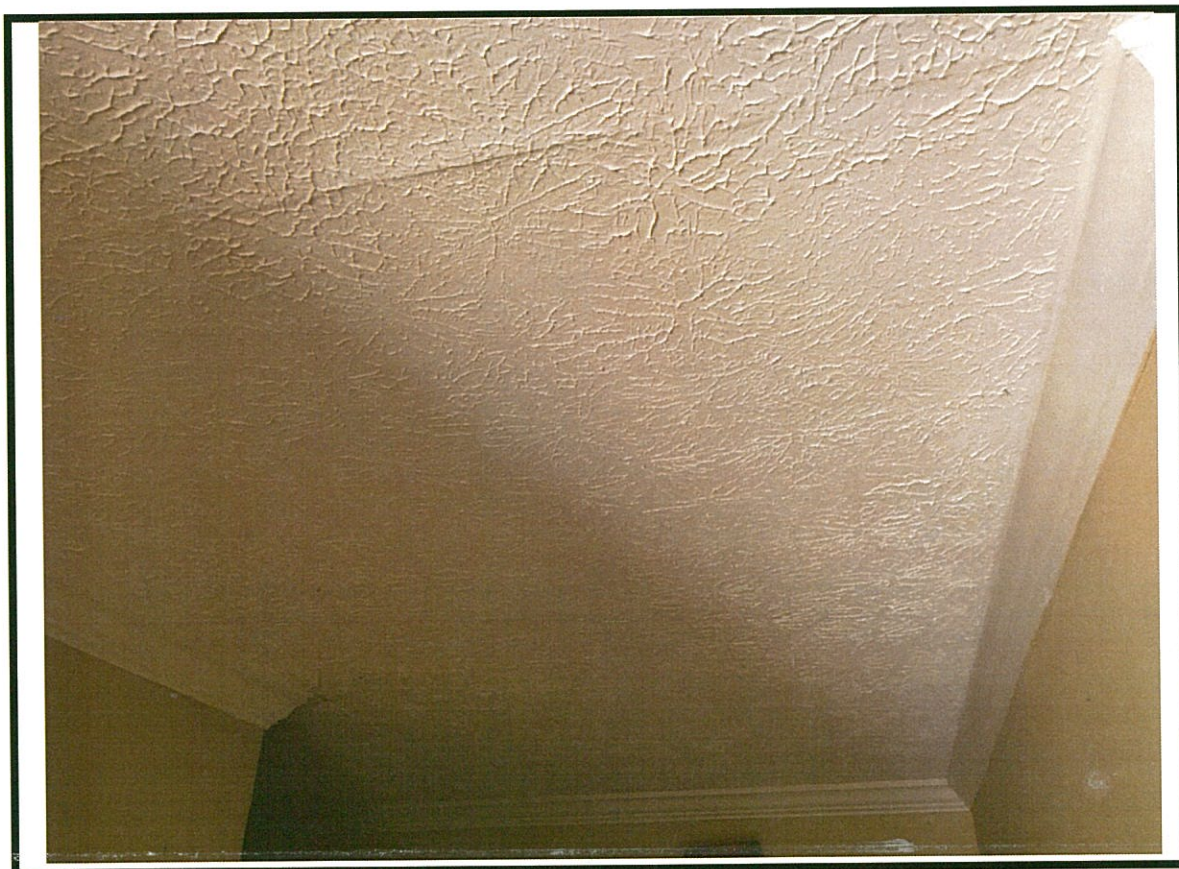
United Consulting collected 21 bulk samples of suspect asbestos containing materials from the Project Site structure. Regulated concentrations of asbestos fibers were detected within 6 of the sampled building materials. Interior building materials that contained regulated concentrations of asbestos fibers included drywall system components and textured ceiling. In addition, a sample of roof mastic contained regulated concentrations of asbestos fibers.

Photo # 6: Textured ceiling within the Project Site building contained regulated concentration of asbestos fibers.

Even though not all sampled and tested, it should be assumed that all drywall system components, textured ceiling and roof mastic at the Project Site contain regulated concentrations of asbestos fibers. Estimates of the amount of these materials are provided within Table 2. Prior to demolition of the Project Site building, the asbestos-containing materials should be removed by a qualified asbestos abatement contractor.

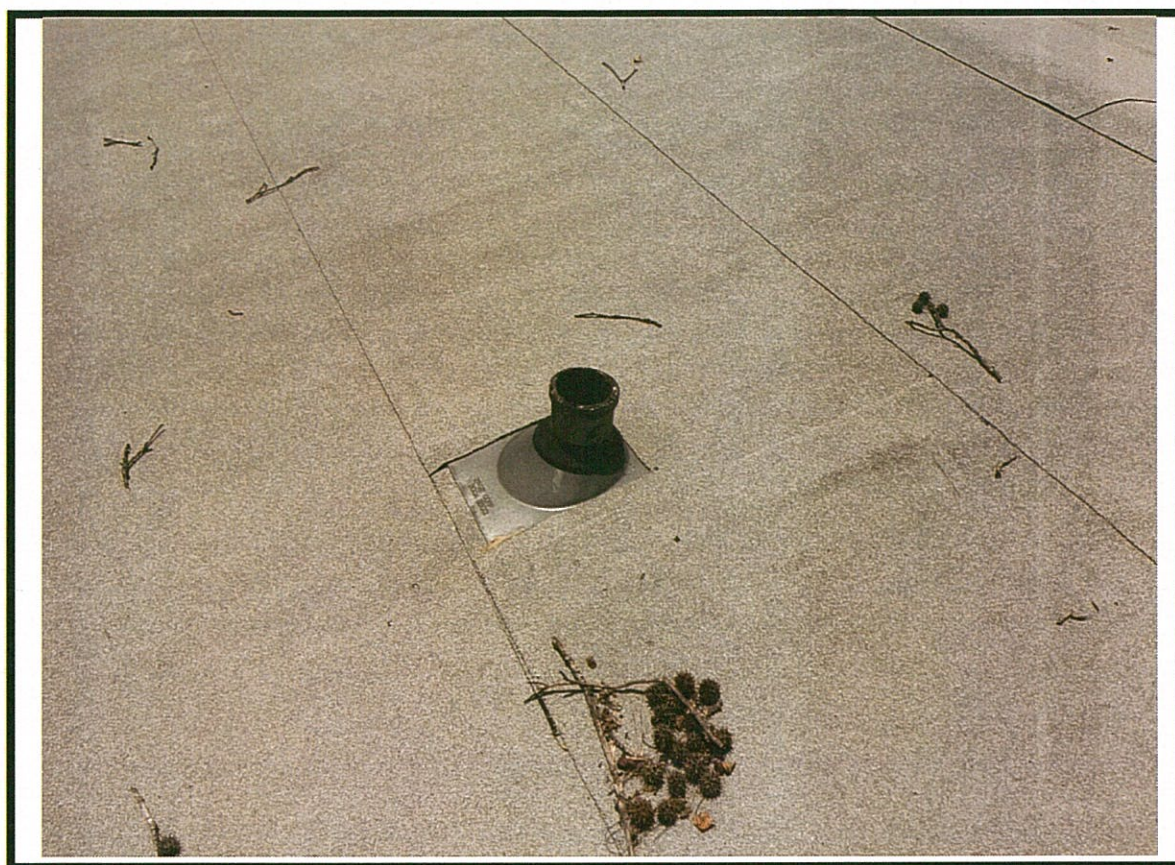
Photo # 7: Mastic off the pictured vent pipe contained regulated concentration of asbestos fibers.
